Analysis stability of rock slope at left bank of South portal of North tunnel – Da Nang – Quang Ngai expressway

Application discontinuity model and failure criterion for anisotropic rock, analysis stability rock slope at left bank of south portal of North tunnel – Da Nang – Quang Ngai expressway.

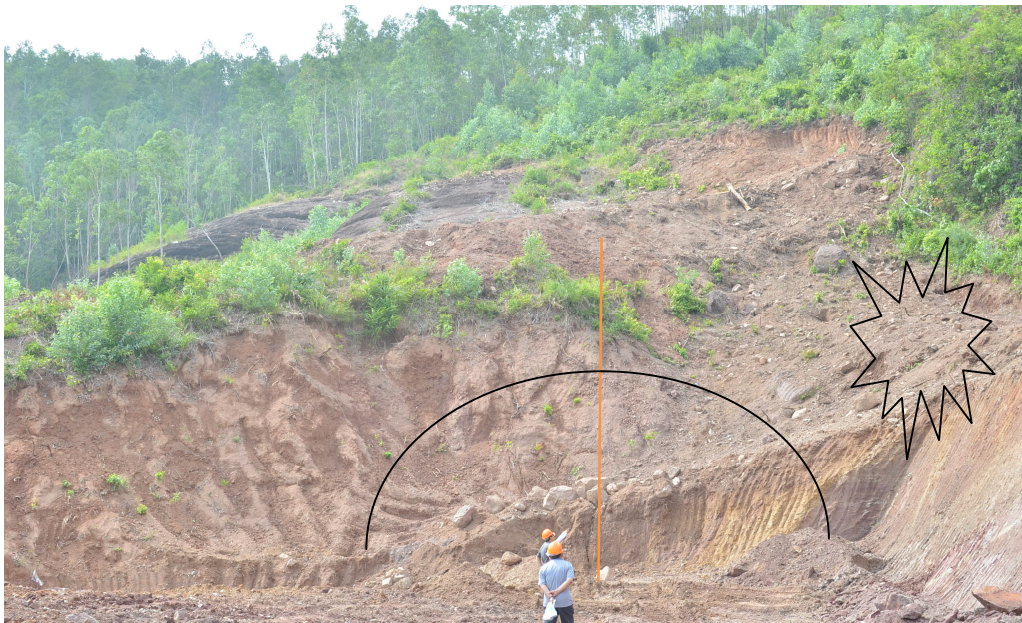
Experts search have incorrect with geotechnical investigation report and in situ analysis of intact rock. In situ intact rock have 2 fault system with grade V, location of faults in region South portal of including tunnel North and South. Intact sandstone location in left side of South portal of tunnel north has 3 faults system and bedding system. The bedding system have direction angle 15° - 20° , fault system perpendicular with bedding system have direction angle 75° - 80° ; fault system overlap with face of rock slope have direction angle perpendicular with axis tunnel.

Fig. 1 South portal of North tunnel, fault zone grade V, right side main view from South portal;

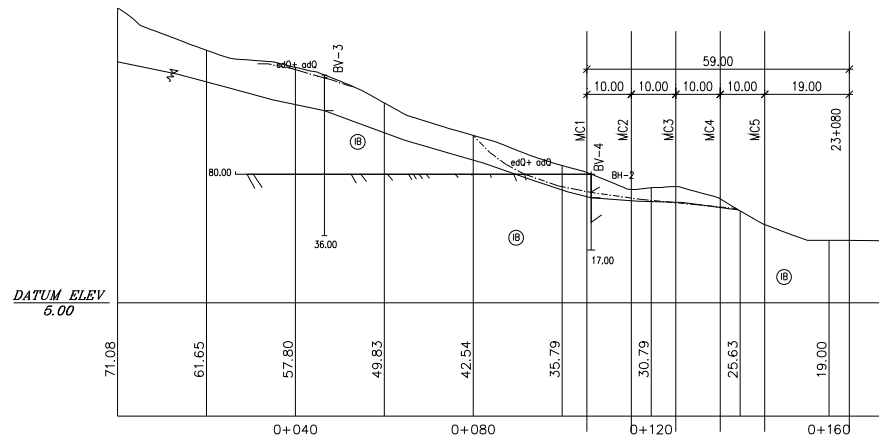
Fig. 2: Section geological structure of axis expressway;

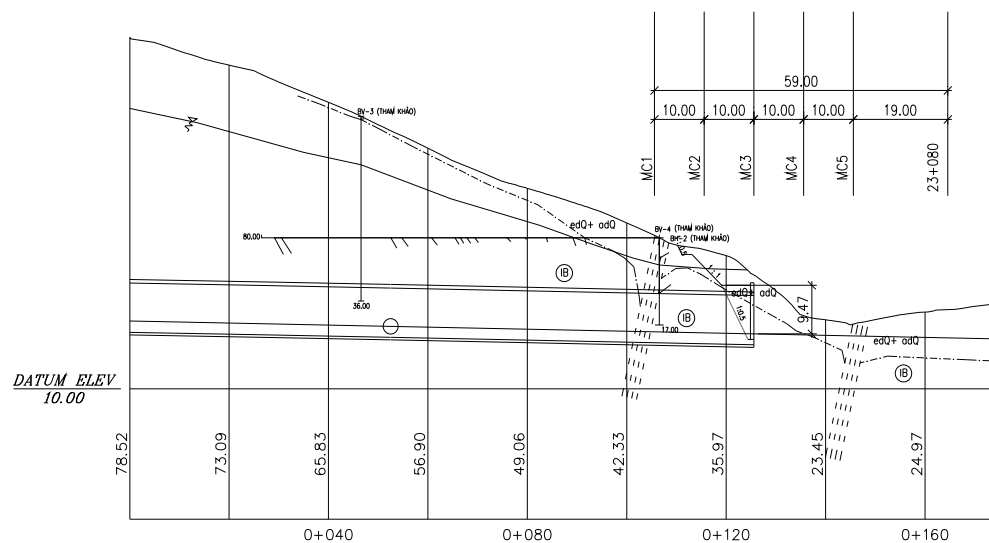
Fig. 3: Profile section geological of axis North tunnel, South portal;

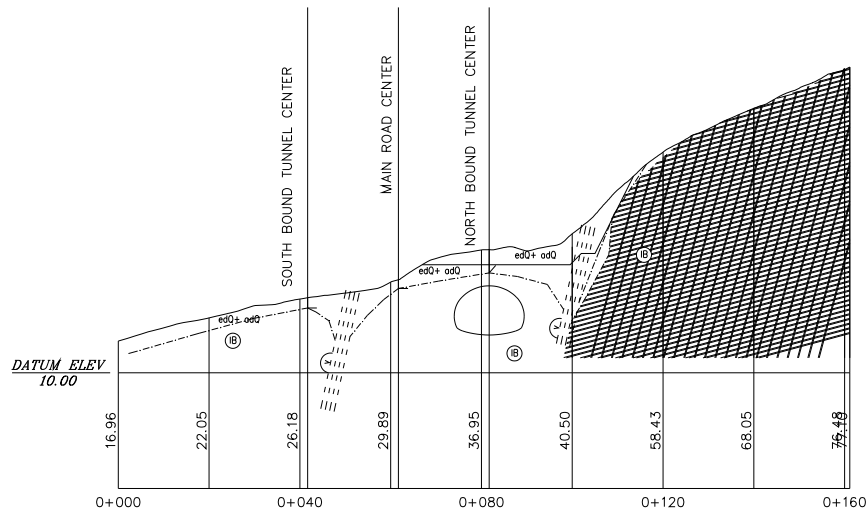
Fig. 4: Cross Section geological – MC02;

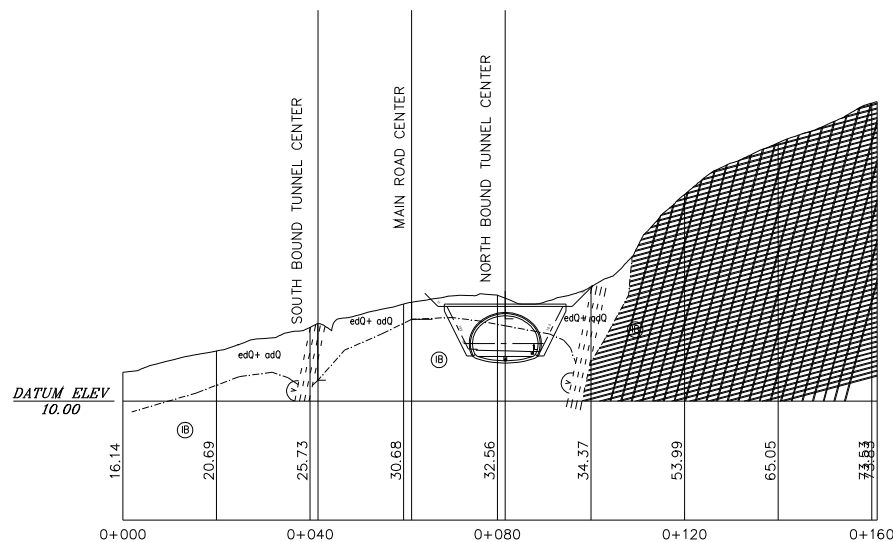
Fig. 5: Cross Section geological – MC03;

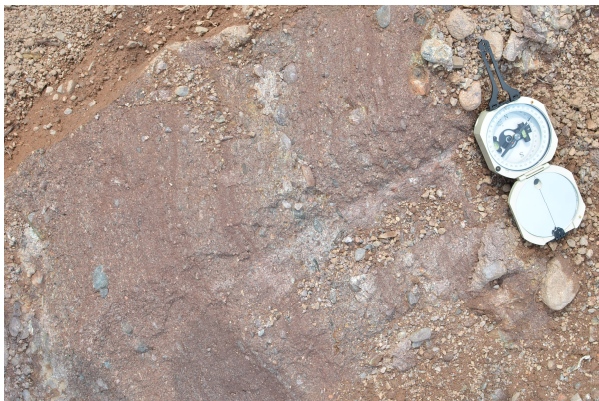
Fig. 6: Sandstone has dark red-sandwiched grave;

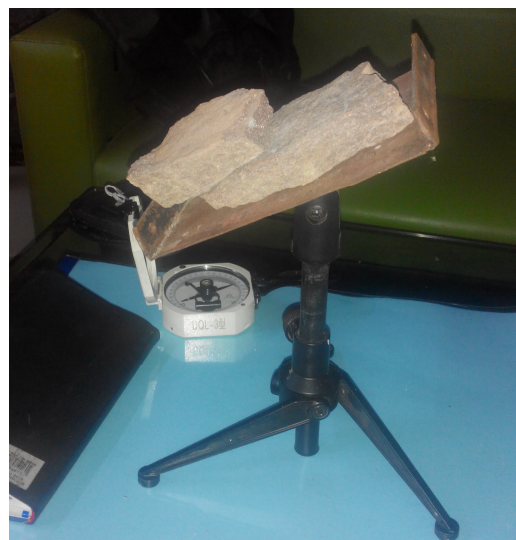
Fig. 7: Experiment determine friction internal angle of intact rock by rock bars

In the Fig. 7, showed the experiments determine friction internal angle of intact rock by rock bars in construction site is experiment simply shear test. Rock bars form intact rock have fault rough, stacked two rock bars on equipment and tilting until rock bar begin sliding as gravity weight itself. Determine angle minimum when begin sliding by geological compass. This angle is friction internal angle of intact rock (Barton and Choubey, 1977).

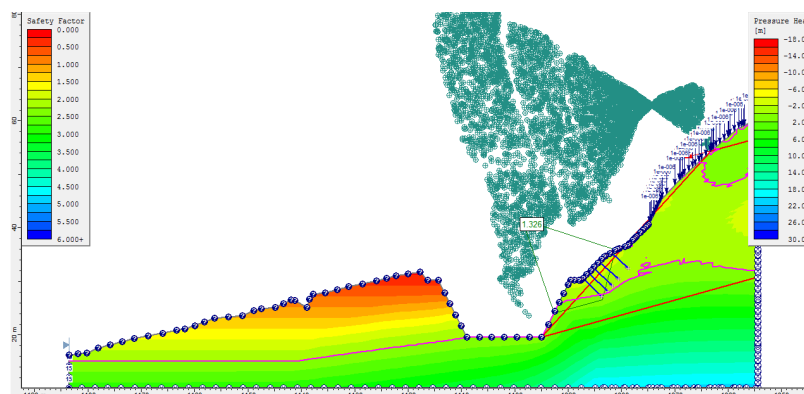
Fig. 8: Result analysis non - circular slipping;

Case of analysis	Non circular slope
	Janbu simply
Case 1	6.628
Case 3	1.046
Case 4	1.326

Analysis stability have support by anchors with tensile capacity equal 300kN, spacing 2m; Bond length with 10% anchor length, length anchors equal 6.0m, (type anchors SND32)

Thus, we need to support by anchors. Results analysis stability is satisfy Korea standard for case condition most unfavorable, with have supportby anchors bar have tensile strength 300kN, spacing 2m, bond length equal 10% length anchors with length anchors equal 6m, type SND32; results in case 4th shown slope is stability with $FS > [FS] = 1,20$.
